**Flood Control Project Maintenance  
Levee Inspections**

**Fall 2011 Levee Maintenance Deficiency Summary Report**

**Reclamation District No. 0536 Egbert**

**Levee Inspection Report By Mile - Fall 2011**

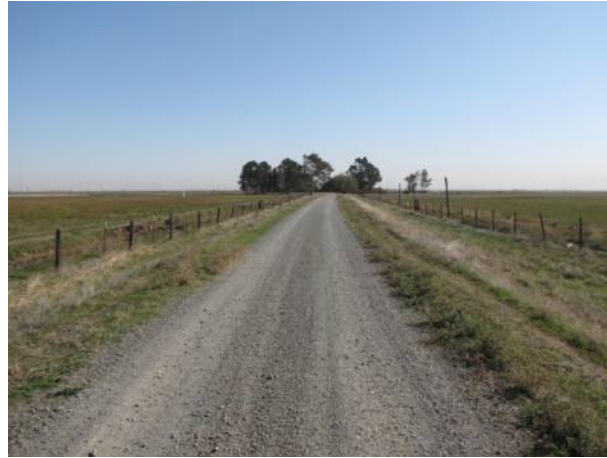
Levee Mile Report Line	1
Start Levee Mile	0.04
End Levee Mile	1.09
Location	Land Side
Category	Earthen Levee
Item	Vegetation

Unit 1 levee mile 0.04 looking downstream to levee mile 1.09. Photo taken 11-01-2011.

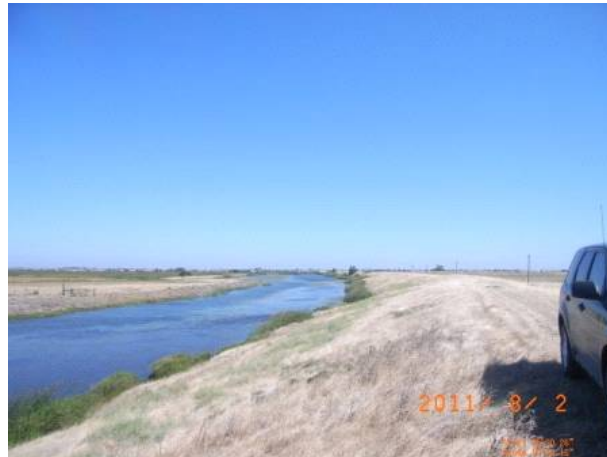
USACE 2011 Photo #1

Levee Mile Report Line	3
Start Levee Mile	0.52
End Levee Mile	0.88
Location	Water Side
Category	Supplemental
Item	USACE Erosion Survey

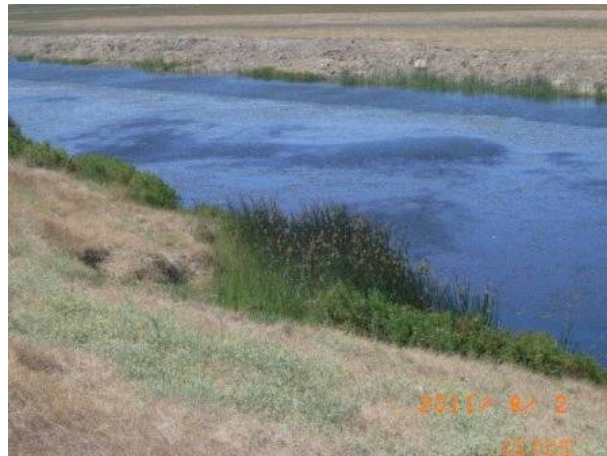
USACE 2011 Photo #2

Levee Mile Report Line	3
Start Levee Mile	0.52
End Levee Mile	0.88
Location	Water Side
Category	Supplemental
Item	USACE Erosion Survey

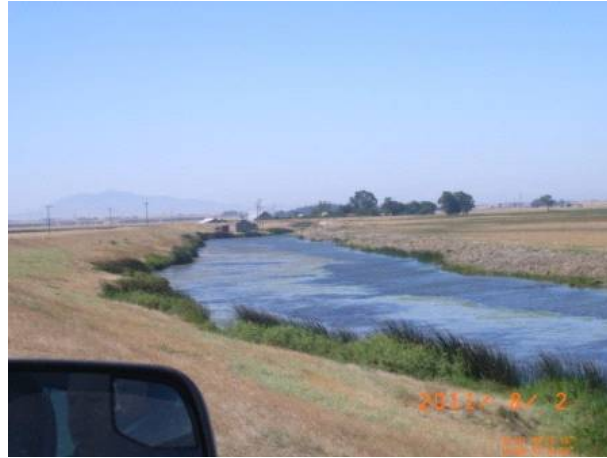
USACE 2011 Photo #3

Levee Mile Report Line	3
Start Levee Mile	0.52
End Levee Mile	0.88
Location	Water Side
Category	Supplemental
Item	USACE Erosion Survey

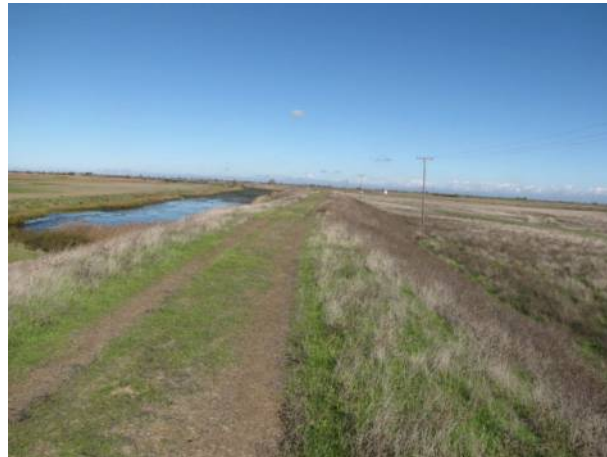
Levee Mile Report Line	5
Start Levee Mile	0.64
End Levee Mile	0.64
Location	Land Side
Category	Earthen Levee
Item	Vegetation

View of levee section Unit 1 RD 536 looking downstream, grasses cover the crown and both levee slopes land side and waterside levee mile 0.64. Photo taken 11-10-2010

5	0.64	0.64	Earthen Levee	Vegetation	LS	M	Remove the wild growth other than native grasses from the levee slopes.	38.249170 ° -121.760185 °	38.249170 ° -121.760185 °	6 Y
6	0.74	0.75	Earthen Levee	Erosion / Bank Caving	LS	M	Note and monitor erosion site.	38.250540 ° -121.759392 °	38.250543 ° -121.759387 °	4 Y
7	0.93	4.28	Earthen Levee	Vegetation	WS	M	Remove the wild growth other than native grasses from the levee slopes.	38.250750 ° -121.749210 °	38.248661 ° -121.717443 °	27 Y
8	1.09	1.80	Earthen Levee	Vegetation	LS	M	Remove the wild growth other than native grasses from the levee slopes.	38.255387 ° -121.757609 °	38.259808 ° -121.749214 °	12
9	1.09	2.52	Earthen Levee	Vegetation	WS	M	Remove the wild growth other than native grasses from the levee slopes.	38.255361 ° -121.757623 °	38.257507 ° -121.738527 °	10
10	1.72	1.76	Earthen Levee	Cracking	CR	M	Monitor and have inspected by geotechnical engineer.	38.259846 ° -121.750813 °	38.259735 ° -121.749959 °	14

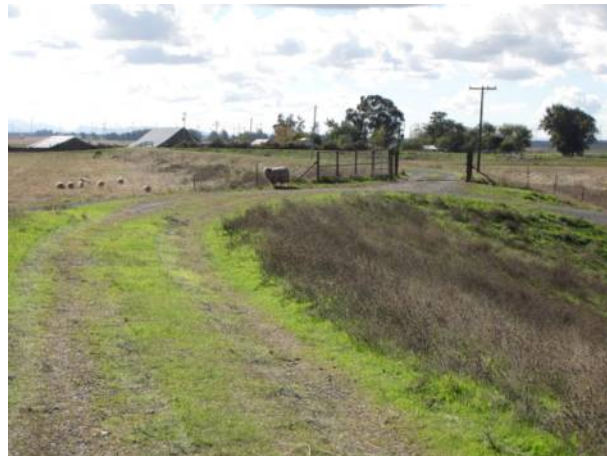
Levee Mile Report Line	5
Start Levee Mile	0.64
End Levee Mile	0.64
Location	Land Side
Category	Earthen Levee
Item	Vegetation

View of levee section RD 536 Unit 1 looking upstream from levee mile 0.64 waterside. Photo taken 11-20-2010

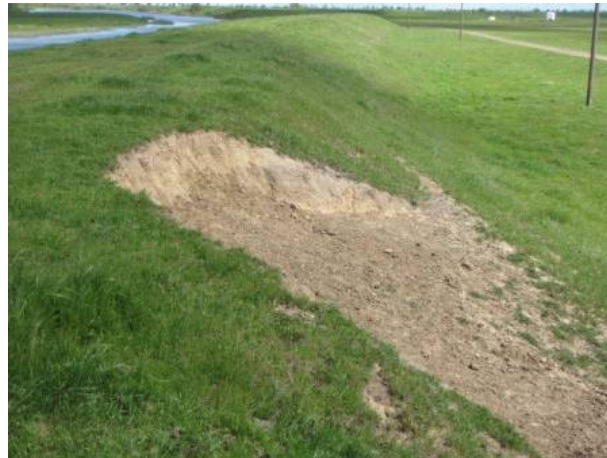
Levee Mile Report Line	6
Start Levee Mile	0.74
End Levee Mile	0.75
Location	Land Side
Category	Earthen Levee
Item	Erosion / Bank Caving
New erosion site located at levee mile 0.74 (38.25054 -121.759392 to 38.250543 - 121.759387. Photo taken 4-7-2011.	
phillips_f_20111010_990.jpg

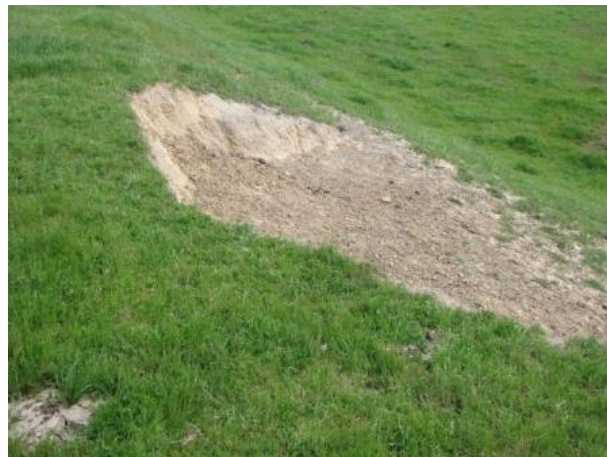
Levee Mile Report Line	6
Start Levee Mile	0.74
End Levee Mile	0.75
Location	Land Side
Category	Earthen Levee
Item	Erosion / Bank Caving
Another view of the erosion along the landside slope levee mile 0.74.	
phillips_f_20111010_991.jpg

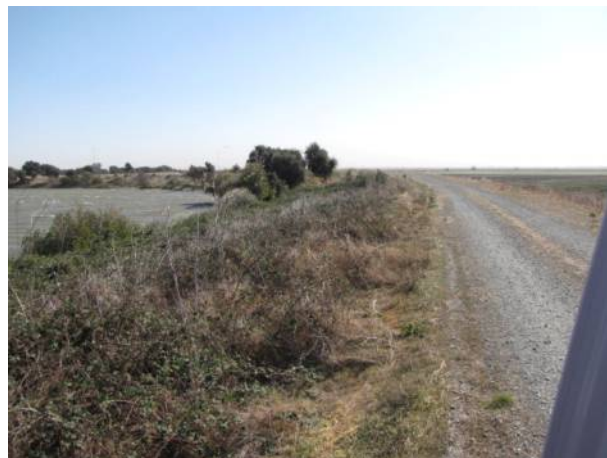
Levee Mile Report Line	7
Start Levee Mile	0.93
End Levee Mile	4.28
Location	Water Side
Category	Earthen Levee
Item	Vegetation
Looking downstream from levee mile 4.29 unit 1 waterside. Photo taken 11-01-2011.	
phillips_f_20111108_026.jpg

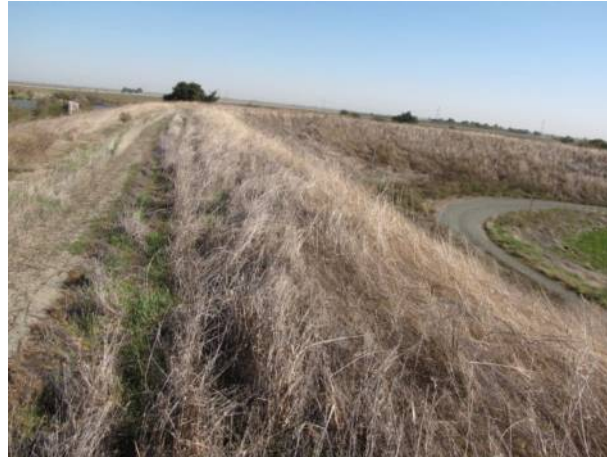
Levee Mile Report Line	11
Start Levee Mile	1.80
End Levee Mile	2.52
Location	Land Side
Category	Earthen Levee
Item	Vegetation

Looking downstream from levee mile 1.82 to 2.52. Photo taken 11-01-2011.

11	1.80	2.52	Earthen Levee	Vegetation	LS	U	Remove the wild growth other than native grasses from the levee slopes.	38.259810 ° -121.749214 °	38.257506 ° -121.738544 °	17 Y
12	2.68	3.20	Earthen Levee	Cracking	CR	M	Monitor and have inspected by geotechnical engineer.	38.255315 ° -121.738007 °	38.256003 ° -121.729599 °	18
13	2.85	3.74	Earthen Levee	Vegetation	LS	U	Remove the wild growth other than native grasses from the levee slopes.	38.255312 ° -121.735273 °	38.251619 ° -121.726119 °	19 Y
14	3.38	3.44	Earthen Levee	Cracking	CR	M	Monitor and have inspected by geotechnical engineer.	38.256471 ° -121.726605 °	38.255736 ° -121.726059 °	20
15	3.74	3.74	Earthen Levee	Crown Surface / Depressions / Rutting	CR	M	Regrade the crown roadway for proper drainage.	38.251620 ° -121.726109 °	38.251619 ° -121.726120 °	22
16	3.76	3.88	Earthen Levee	Crown Surface / Depressions / Rutting	CR	M	Add appropriate gravel or road base. Grade and compact.	38.251905 ° -121.726274 °	38.250832 ° -121.724784 °	11 Y

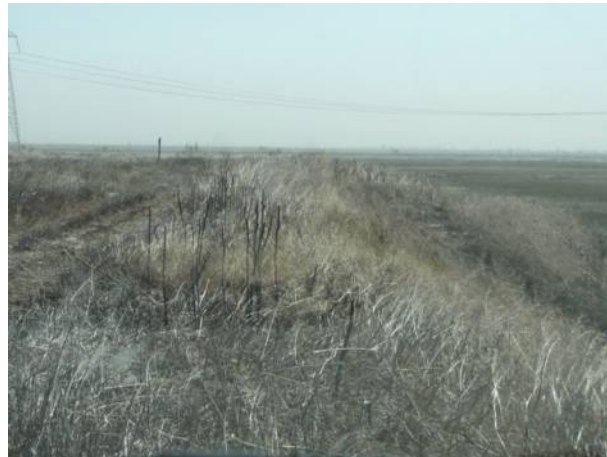
Levee Mile Report Line	13
Start Levee Mile	2.85
End Levee Mile	3.74
Location	Land Side
Category	Earthen Levee
Item	Vegetation

Looking downstream landside unit 1 levee mile 2.85 to levee mile 3.74. Photo taken 11-01-2011.

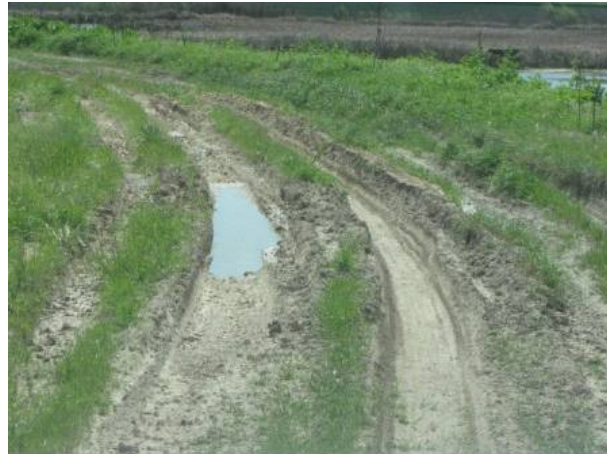
Levee Mile Report Line	16
Start Levee Mile	3.76
End Levee Mile	3.88
Location	Crown
Category	Earthen Levee
Item	Crown Surface / Depressions / Rutting

Photo here shows deep ruts made into the crown roadway, unsatisfactory conditions. This section needs regrading for proper drainage. Photo taken 4-7-2011.

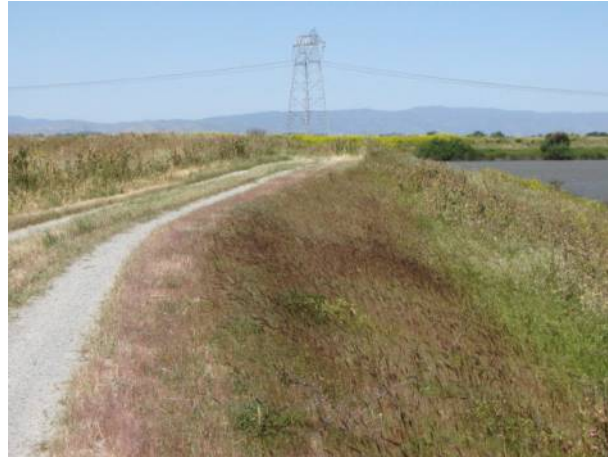
Levee Mile Report Line	17
Start Levee Mile	4.19
End Levee Mile	4.26
Location	Water Side
Category	Earthen Levee
Item	Vegetation

Looking upstream from levee mile 4.21.

LMR No.	Levee Mile		Category	Item	Location *	Rating **	Action/Comment	GPS Latitude/Longitude		Issue No. Photo
	Start	End						Start	End	
17	4.19	4.26	Earthen Levee	Vegetation	WS	M	Remove the wild growth other than native grasses from the levee slopes. Inspector Comments: This levee section has problems with not only veg on crown road way but there are cattle that has caused some damage to the crown. 5-6-2010 DURING THIS INSPECTION, I see that the District has mowed a section of levee.	38.249522 ° -121.718727 °	38.248725 ° -121.717858 °	21 Y
18	4.46	4.46	Earthen Levee	Trim / Thin Trees	LS	C	Trim trees to at least five feet above ground level.	38.249122 ° -121.714686 °	38.249122 ° -121.714686 °	23
19	4.47	4.63	Earthen Levee	Vegetation	WS	M	Remove the wild growth other than native grasses from the levee slopes.	38.249102 ° -121.714504 °	38.248314 ° -121.712021 °	28
20	4.62	4.64	Earthen Levee	Vegetation	WS	M	Remove the wild growth other than native grasses from the levee slopes.	38.248317 ° -121.712075 °	38.248118 ° -121.711935 °	13

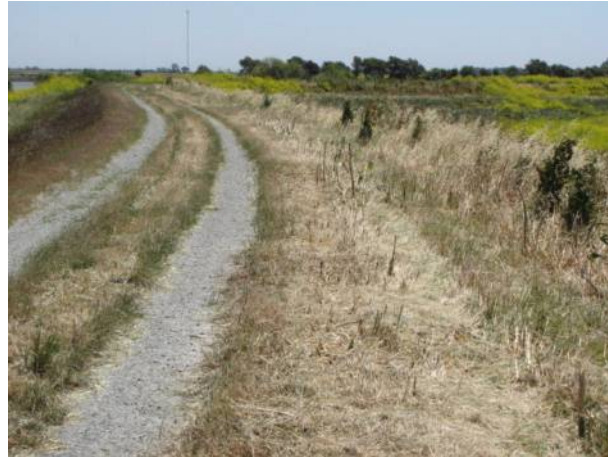
Levee Mile Report Line	17
Start Levee Mile	4.19
End Levee Mile	4.26
Location	Water Side
Category	Earthen Levee
Item	Vegetation

Looking downstream from levee mile 4.21

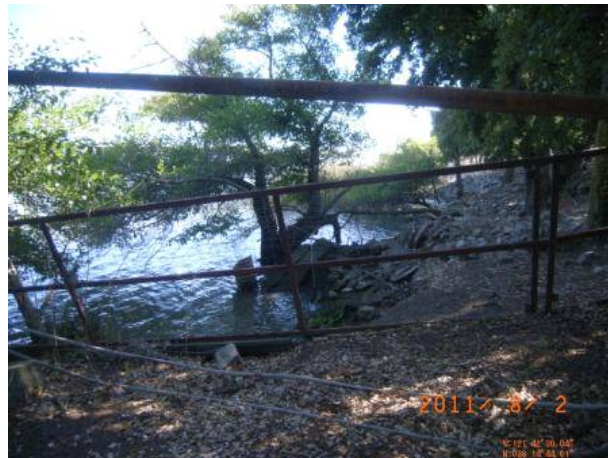
USACE 2011 Photo #1

Levee Mile Report Line	25
Start Levee Mile	4.83
End Levee Mile	4.86
Location	Water Side
Category	Supplemental
Item	USACE Erosion Survey

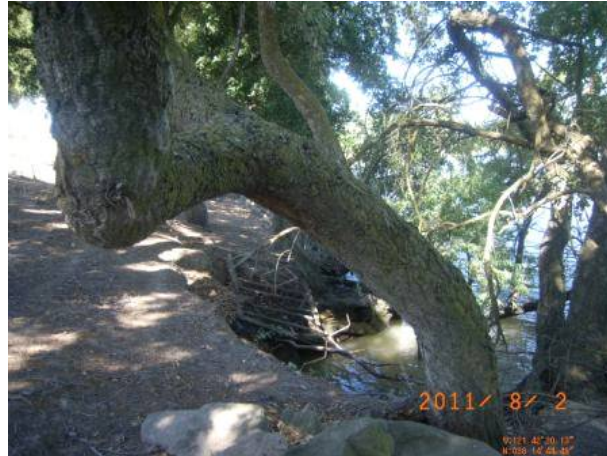
USACE 2011 Photo #2

Levee Mile Report Line	25
Start Levee Mile	4.83
End Levee Mile	4.86
Location	Water Side
Category	Supplemental
Item	USACE Erosion Survey

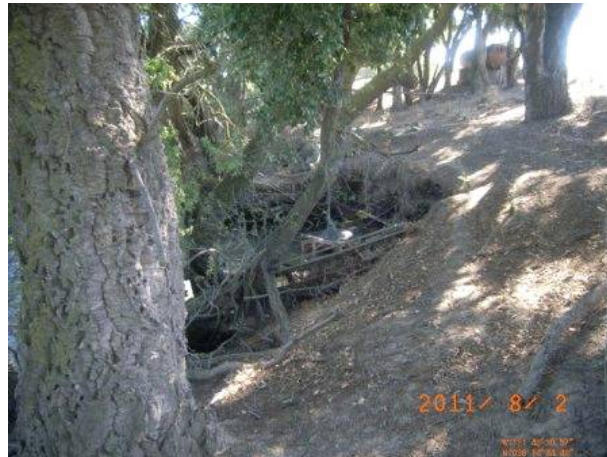
USACE 2011 Photo #3

Levee Mile Report Line	25
Start Levee Mile	4.83
End Levee Mile	4.86
Location	Water Side
Category	Supplemental
Item	USACE Erosion Survey

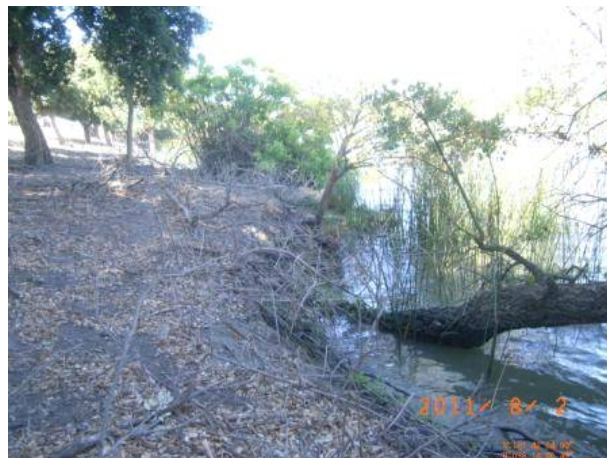
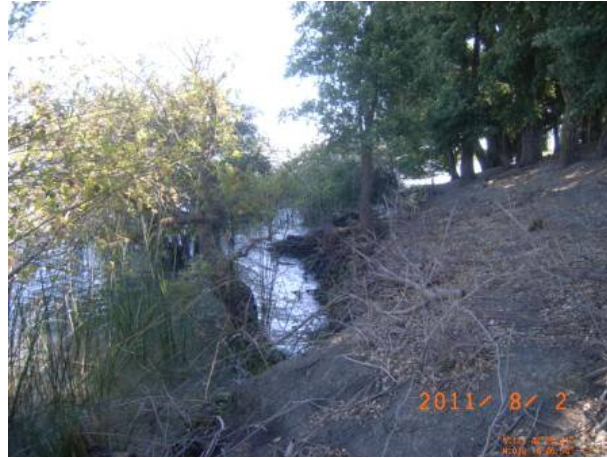
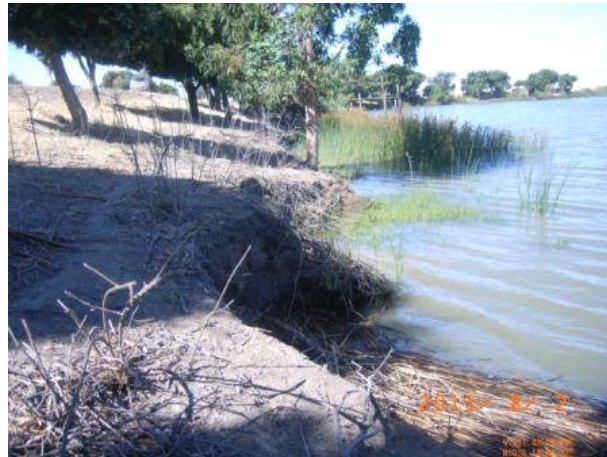
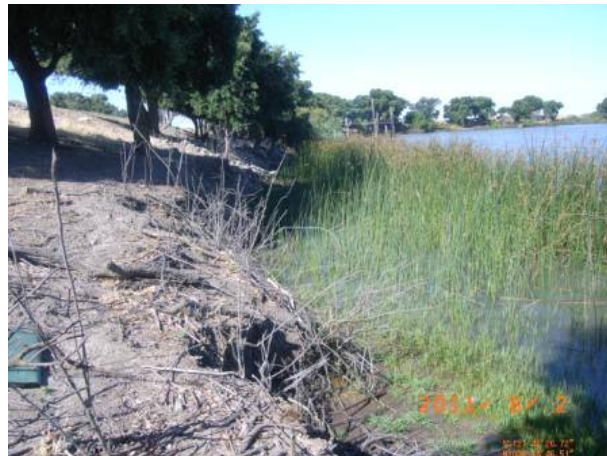
26	4.90	5.03	Supplemental	USACE Erosion Survey	WS	M	Inspector Comments: 2011: Levee toe is unraveling with large slumping sections. This site is downstream of old bank rock. [2011 Site ID: LDS_0-7_R]	38.245981 ° -121.707609 °	38.246326 ° -121.706737 °	25 Y
27	4.90	4.94	Earthen Levee	Vegetation	WS	M	Remove the wild growth other than native grasses from the levee slopes.	38.245427 ° -121.708922 °	38.245597 ° -121.708290 °	26
28	5.21	5.40	Earthen Levee	Vegetation	LS	M	Remove the wild growth other than native grasses from the levee slopes.	38.245339 ° -121.704304 °	38.245786 ° -121.700859 °	29
29	5.39	5.42	Earthen Levee	Vegetation	LS	M	Remove the wild growth other than native grasses from the levee slopes.	38.245602 ° -121.702037 °	38.245628 ° -121.700970 °	5

Levee Mile Report Line	26
Start Levee Mile	4.90
End Levee Mile	5.03
Location	Water Side
Category	Supplemental
Item	USACE Erosion Survey

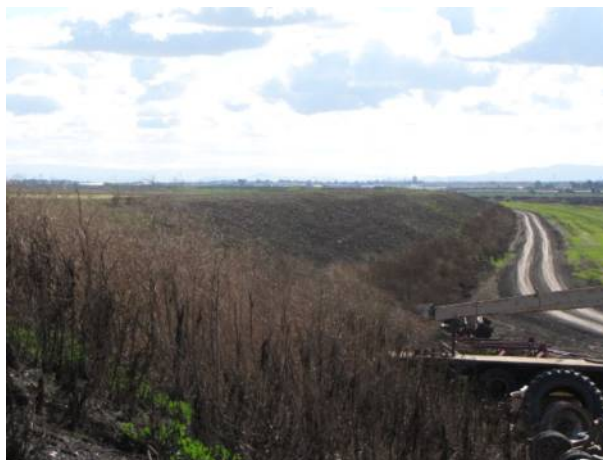
Levee Mile Report Line	1
Start Levee Mile	0.00
End Levee Mile	0.00
Location	Land Side
Category	Earthen Levee
Item	Vegetation

View of land side RD 536 Unit 2 looking downstream from levee mile 0.00 Photo taken 11-10-2010

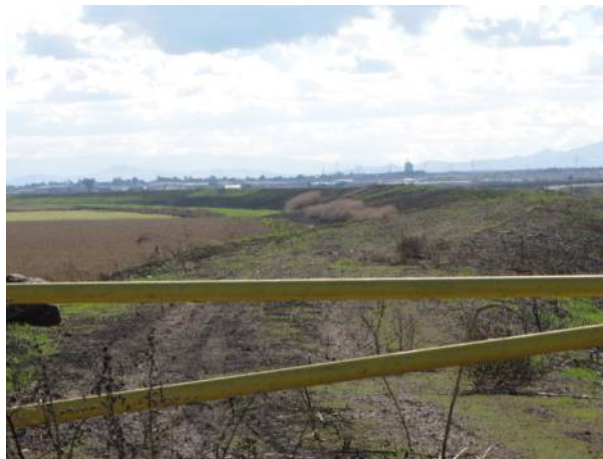
Levee Mile Report Line	1
Start Levee Mile	0.00
End Levee Mile	0.00
Location	Land Side
Category	Earthen Levee
Item	Vegetation

View of levee section looking downstream from levee mile 0.00 waterside RD 536 Photo taken 10-20-2010.

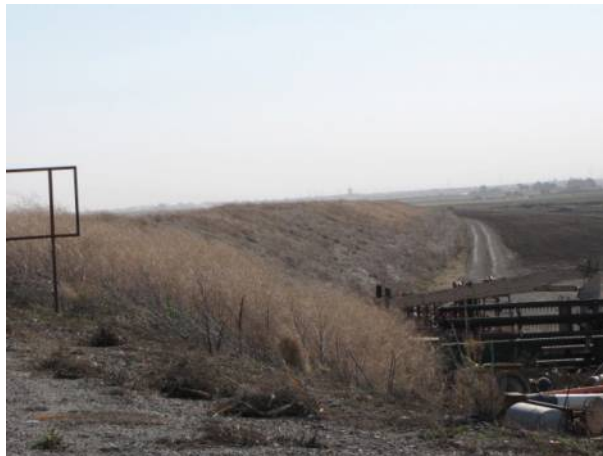
Levee Mile Report Line	1
Start Levee Mile	0.00
End Levee Mile	0.00
Location	Land Side
Category	Earthen Levee
Item	Vegetation

Landside levee mile 0.00 looking downstream unit 2 RD 536. Photo taken 11-01-2011.

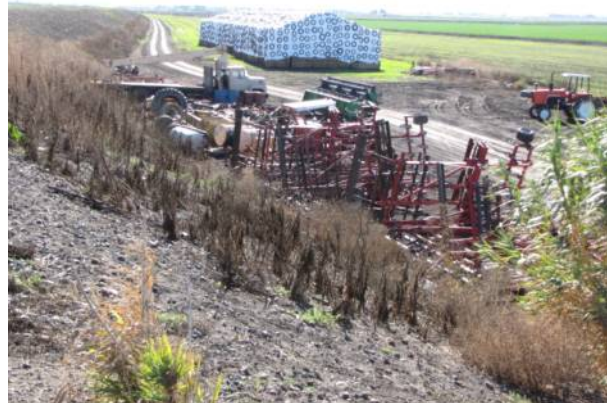
Levee Mile Report Line	2
Start Levee Mile	0.01
End Levee Mile	0.06
Location	Land Side
Category	Earthen Levee
Item	Encroachments

View of unauthorized encroachment levee miles 0.01-0.06 land side of RD 536 Unit 2. Farmer has stored equipment, materials and vehicle within 10-foot of landward toe. Photo taken 11-10-2010

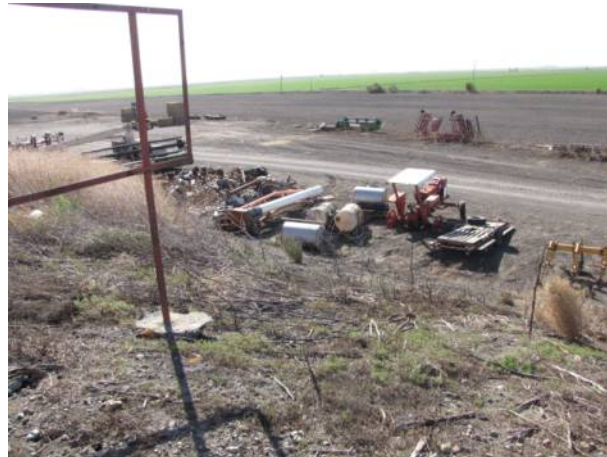
Levee Mile Report Line	2
Start Levee Mile	0.01
End Levee Mile	0.06
Location	Land Side
Category	Earthen Levee
Item	Encroachments

Photo showing equipment within 10-foot of landward toe. Photo taken 11-01-2011.

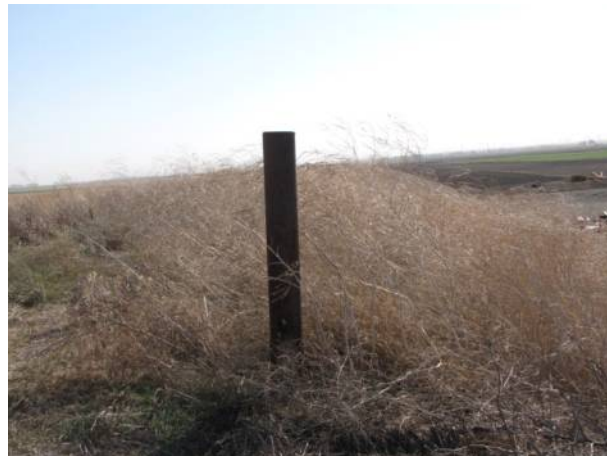
Levee Mile Report Line	3
Start Levee Mile	0.04
End Levee Mile	0.10
Location	Land Side
Category	Earthen Levee
Item	Vegetation

Landside of unit 2 looking downstream from gate levee mile 0.04 -0.10. Photo taken 11-01-2011.

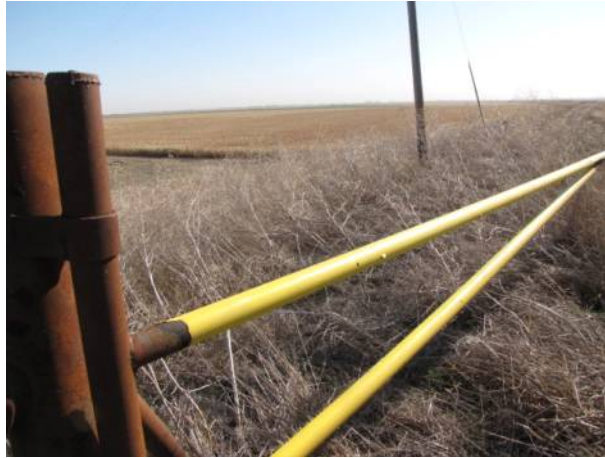
Levee Mile Report Line	4
Start Levee Mile	0.04
End Levee Mile	0.10
Location	Water Side
Category	Earthen Levee
Item	Vegetation
Unsatisfactory wild growth waterside from gate looking downstream. Photo taken 11-01-2011.	
phillips_f_20111109_032.jpg

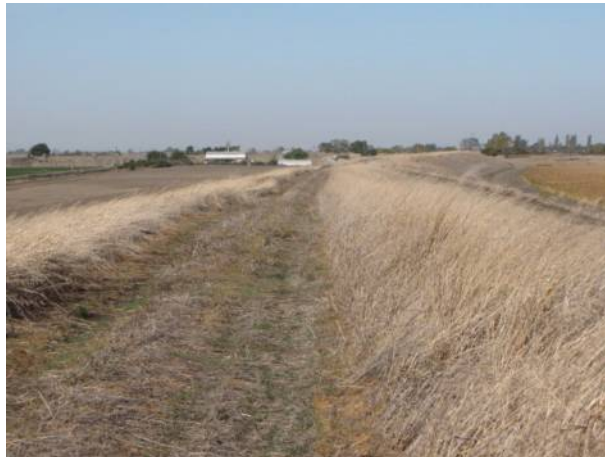
Levee Mile Report Line	5
Start Levee Mile	0.04
End Levee Mile	2.10
Location	Crown
Category	Earthen Levee
Item	Vegetation
Looking upstream levee mile 2.10 back to levee mile 0.00 from the waterward shoulder. Photo taken 11-01-2011.	
phillips_f_20111109_031.jpg

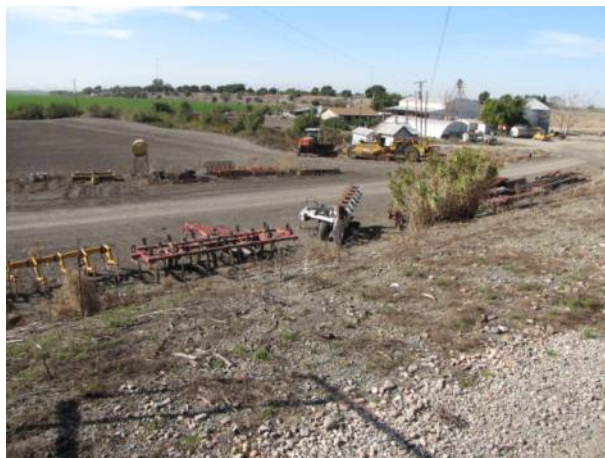
Levee Mile Report Line	6
Start Levee Mile	0.04
End Levee Mile	0.10
Location	Land Side
Category	Earthen Levee
Item	Encroachments
Encroachment land side within 10-foot of levee toe. Photo taken 11-01-2011.	
phillips_f_20111109_033.jpg

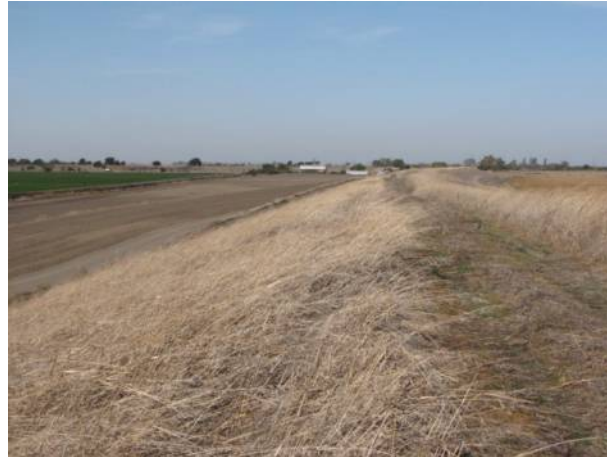
Levee Mile Report Line	9
Start Levee Mile	0.11
End Levee Mile	2.03
Location	Water Side
Category	Earthen Levee
Item	Vegetation

Unsatisfactory growth on landward slope looking upstream from levee mile 2.03 to levee mile 0.11. Photo taken 11-01-2011.
